DESIGN AND EVALUATION OF HYDRAULIC LIME GROUTS FOR *IN SITU*
REATTACHMENT OF LIME PLASTER TO EARTHEN WALLS

Angelyn Bass

A THESIS

Historic Preservation

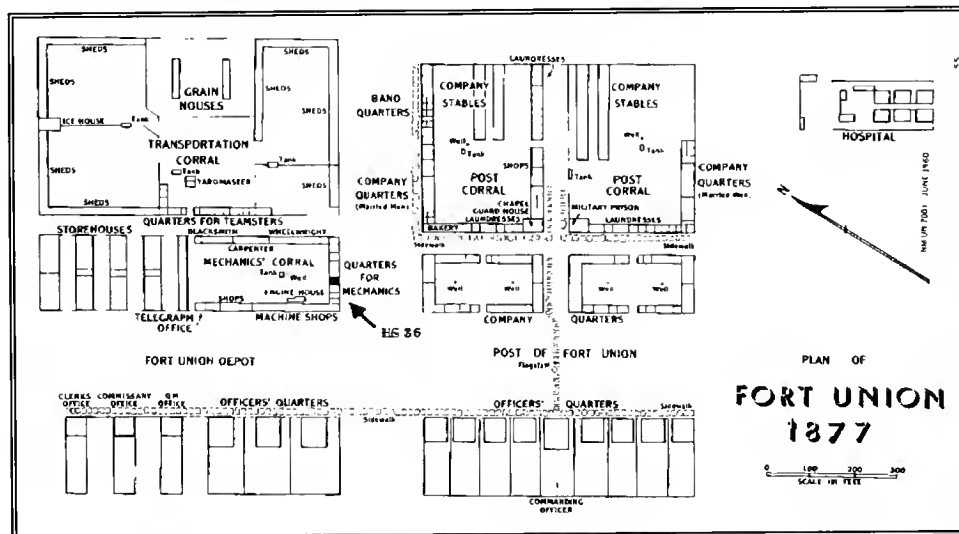
Figure 1. Plan of Fort Union in 1877. HS 36, known as the Mechanics Corral, was the area selected by the NPS for plaster conservation treatment. The darkened area is room 24, where one of the adobe samples analyzed in this testing program was taken. (from Utley, 1962)

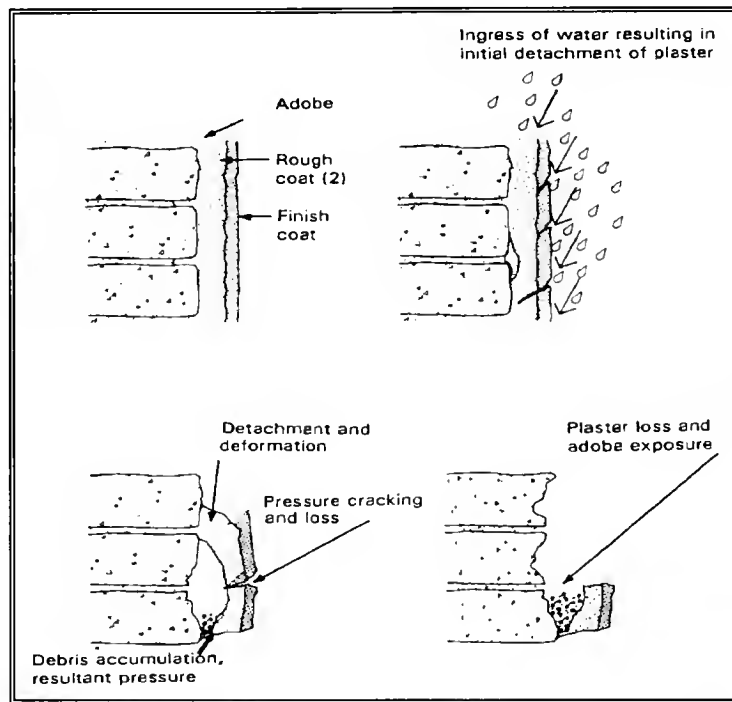
Figure 2. Schematic of plaster detachment processes at Fort Union NM.
(from Matero 1995, 14; designed by Maribel Beas)

The principal deterioration mechanism causing loss of adhesion and detachment of the Fort Union plasters was the infiltration of water behind the plaster. As water penetrated through cracks or along broken edges of plaster, it softened the adobe, causing it to lose cohesion and weaken the bond between the plaster and the supporting adobe wall. Eventually, the partially unsupported plaster deformed and became displaced, forming a void where loose debris could accumulate. The stress caused by this action progressively led to more cracking and eventual plaster loss. Secondary deterioration mechanisms were the intrinsic weakness of the bond between lime and adobe, made worse by poor quality of original construction achieved by untrained army personnel who knew little about durable adobe construction.

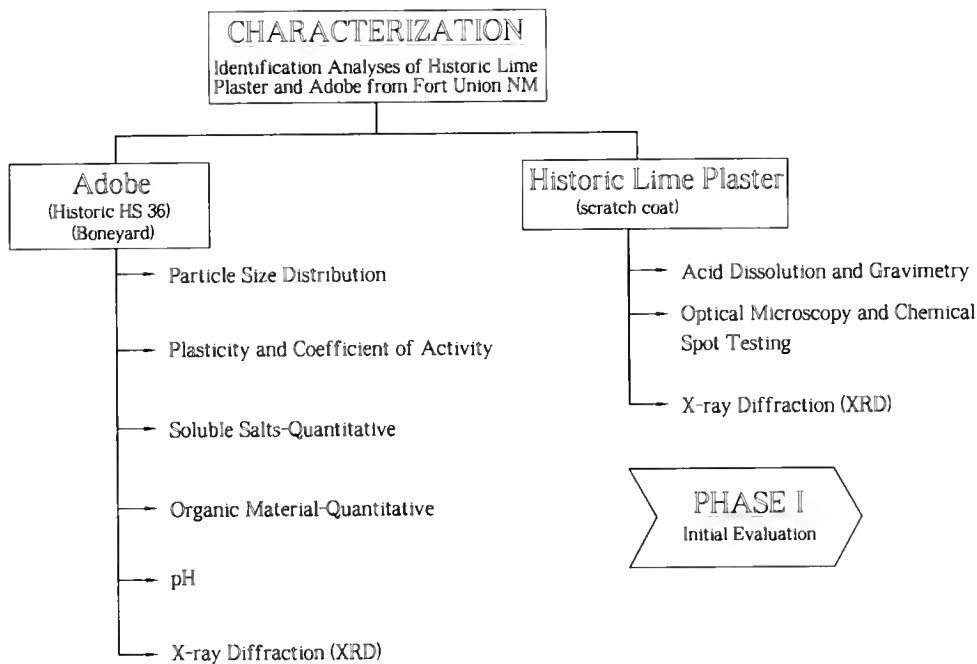
Figure 3. Flow chart of characterization tests conducted on Fort Union adobe and plaster samples

1. carbonate content by acid dissolution and gravimetry
2. examination of stratigraphy by optical microscopy
3. identification of sulfates by microchemical spot testing
4. determination of crystalline components by X-ray diffraction (XRD)

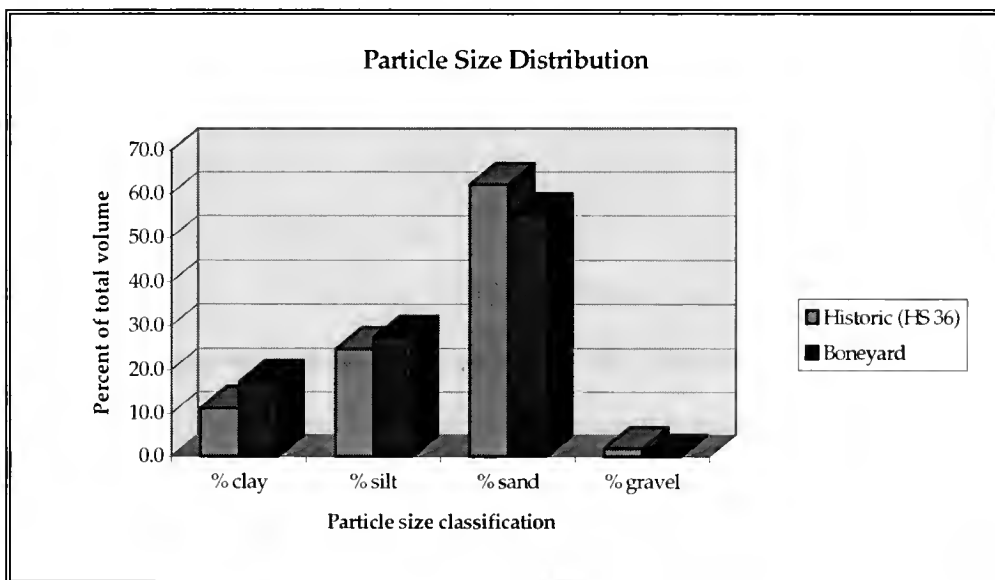
Figure 4. Adobe particle size distribution graph

Discussion - The results of the particle size analysis show that the HS 36 sample is composed of 62% sand, 25% silt, and 11% clay (weight percentages). The Boneyard sample consists of 55% sand, 27 % silt, and 17% clay (weight percentages). According to the Unified Soil Classification System (Wagner 1957), the soil in both adobe samples is considered coarse and is classified as a silty sand.

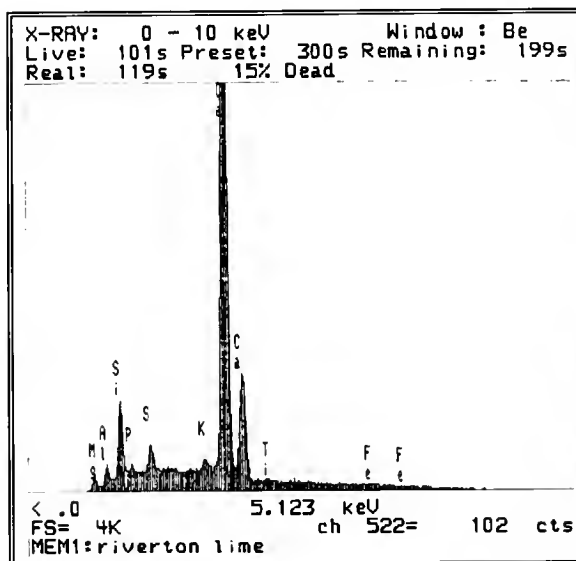
Figure 5. SEM/EDS spectrum of Riverton hydrated hydraulic lime (from Matero 1995, 98)

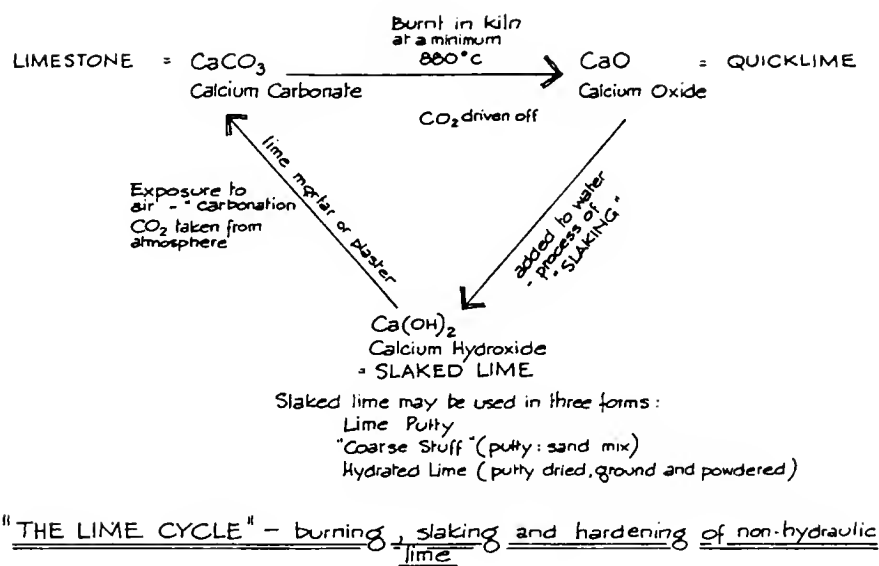
Figure 6. The lime cycle --burning, slaking, and setting of non-hydraulic lime (Ashurst 1988, 2)

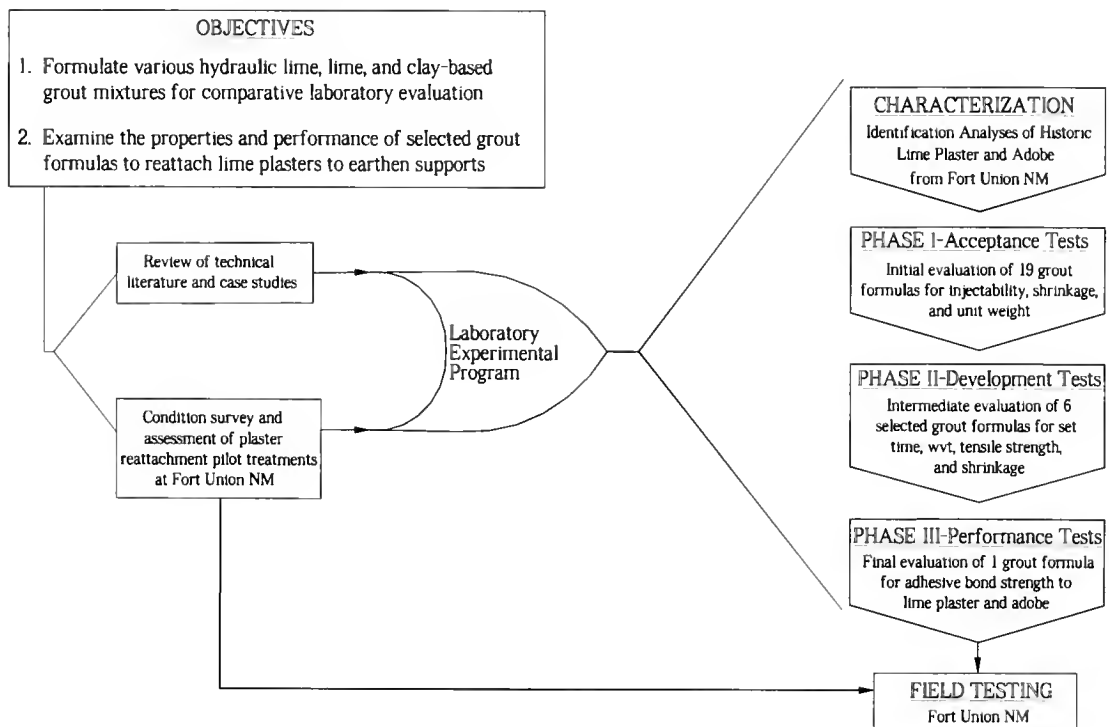
Figure 7. Experimental program activity flow chart

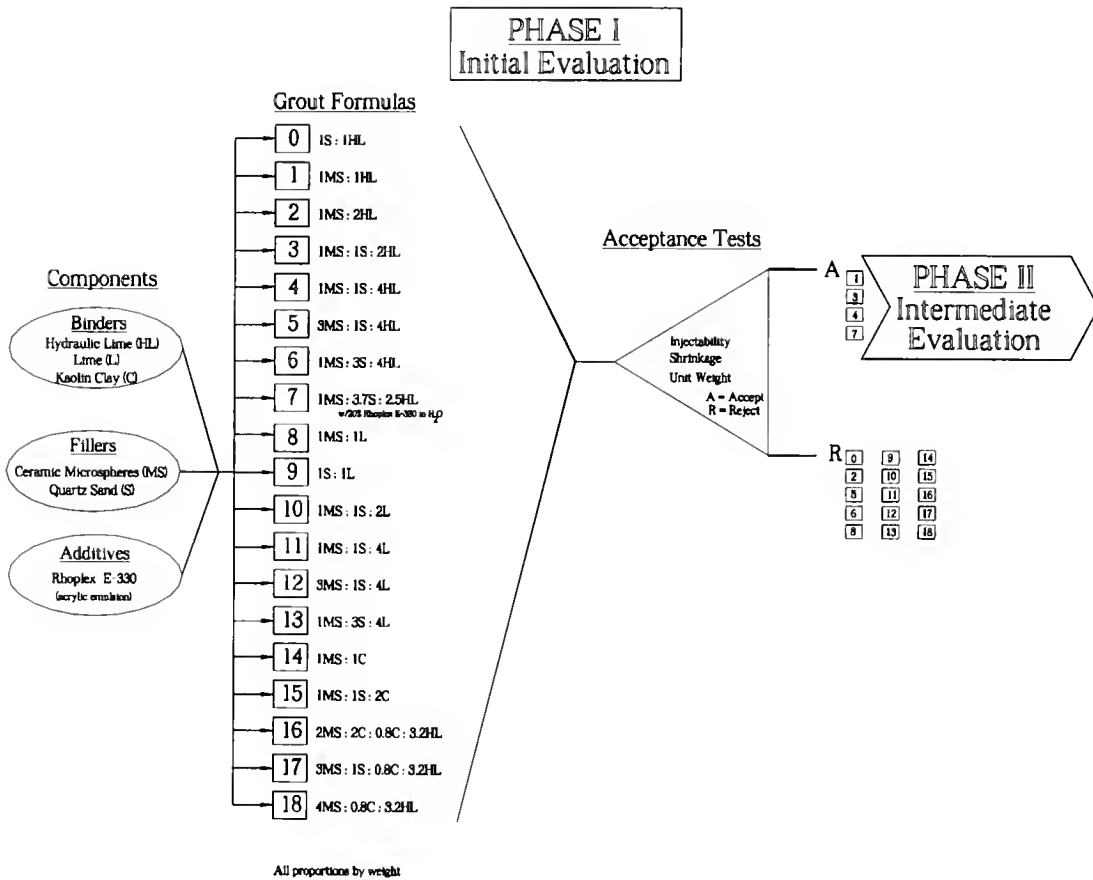
Figure 8. Phase I activity flow chart

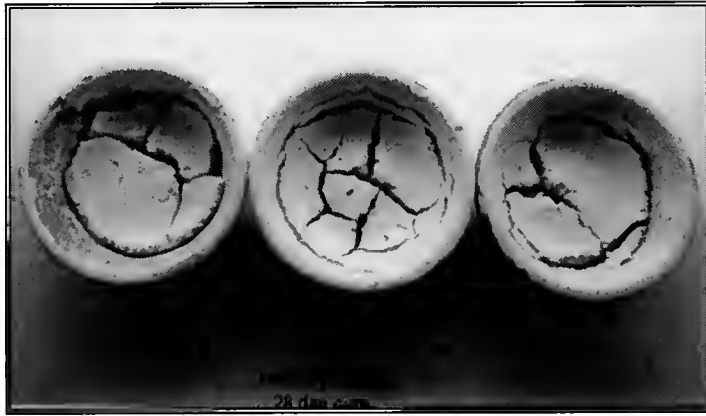
Figure 9. Phase I shrinkage test. Sample #15 with clay as the binder. Note extensive concentric cracking and shrinkage. At initial pour the grout was filled to the rim of the dish.

Most of the grout formulas exhibited some form of shrinkage cracking. Three principal cracking patterns were observed: *concentric cracking* -- long, continuous cracks on the surface and

within the grout, that often spiraled out from the center; *perimeter cracking* -- where the grout contracted uniformly towards the center and detached from the rim of the clay dish; and *straight line cracks* -- narrow, short, straight cracks that formed on the surface just after initial set.

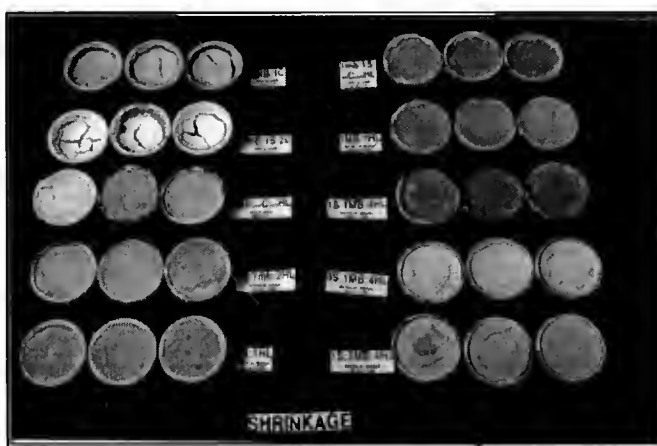
Figure 10. Phase I shrinkage test dishes after 28 day cure

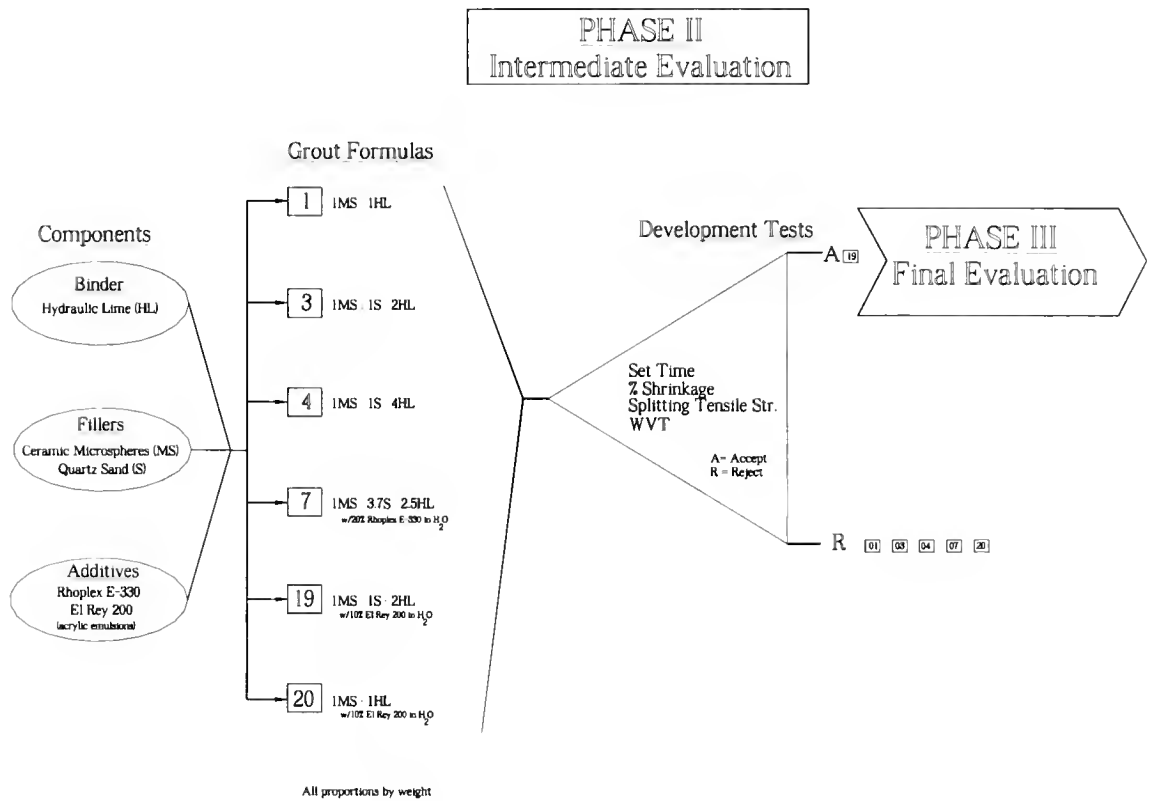
Figure 11. Phase II activity flow chart

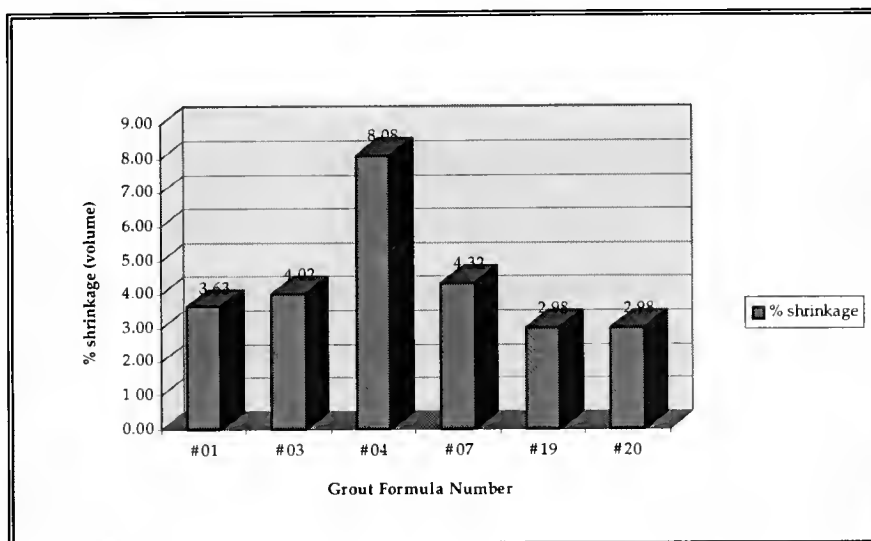
Figure 12. Graph of percent shrinkage test results

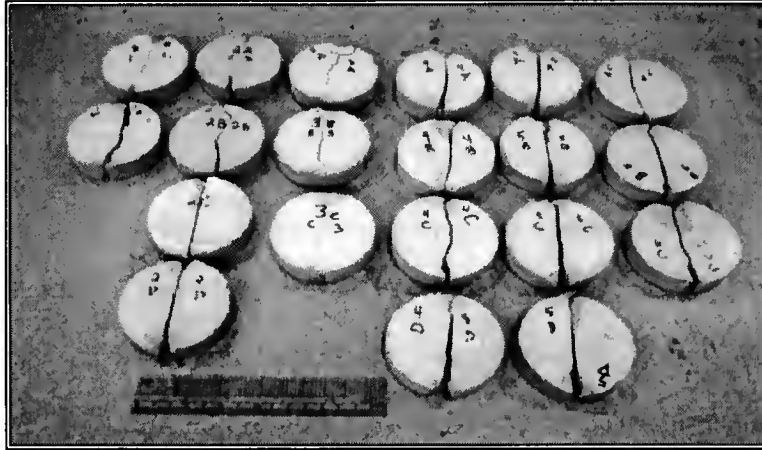
Figure 14. Grout samples after failure from compressive loading

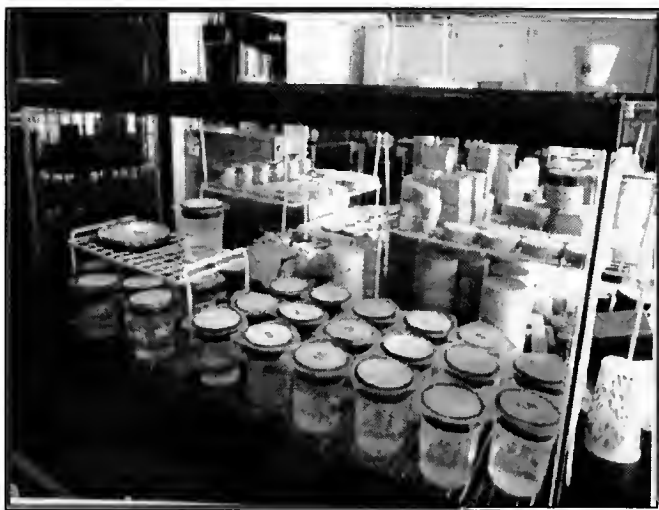
Figure 15. Water vapor transmission testing chamber with grout and adobe samples under testing

Using the standard water method, a grout or adobe specimen was sealed with paraffin over a beaker of distilled water and placed in a sealed, climate and humidity controlled glass

chamber²⁸. Three dish assemblies were made for each six grout types. One "dummy" dish assembly, made by sealing a sample over a dish without water, was made for each specimen type and served as a control. The dish assemblies were weighed daily on an electronic scale with a sensitivity of 0.01g and recorded and corrected using the dummy assemblies. After the

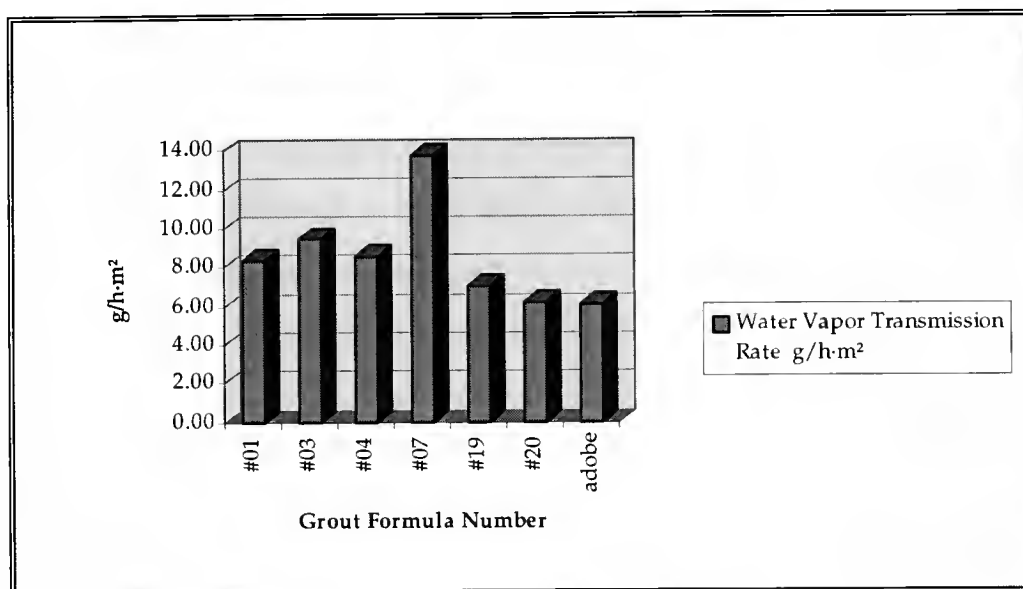
Figure 16. Graph of relative water vapor transmission rates

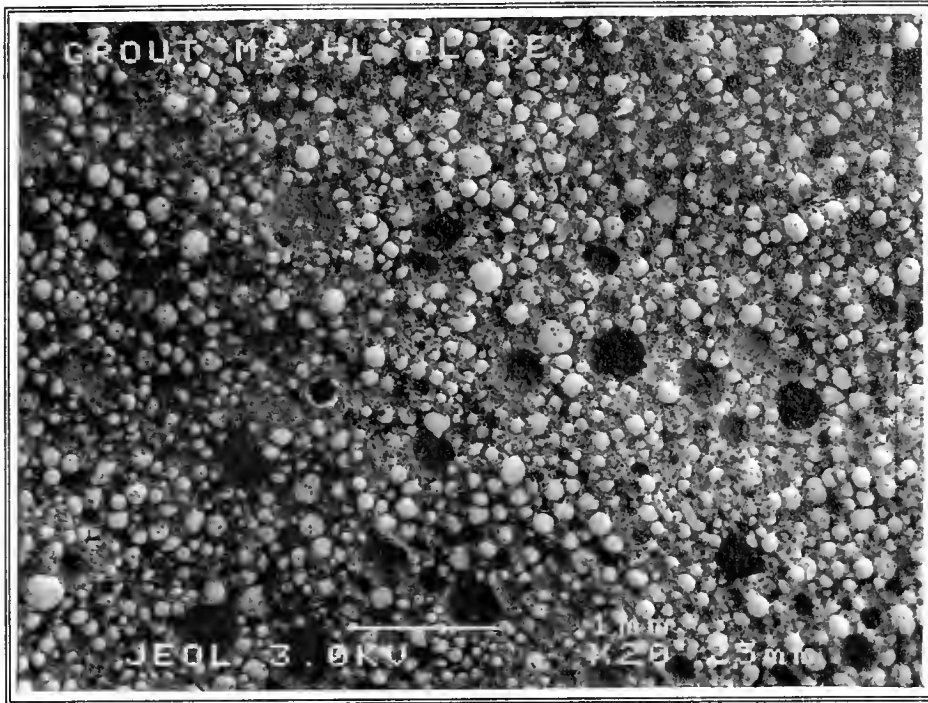
Figure 17. SEM photomicrograph of grout formula #20, showing a well dispersed matrix of ceramic microspheres and hydraulic lime. The vacuoles are a result of the El Rey acrylic additive foaming during mixing. White scale bar length is 1mm. (20x)

At magnifications of 20x and 150x the SEM photomicrographs clearly show the structure of the cured grouts to be homogeneous and uniform. One can clearly see the ceramic microspheres, and in some cases sand, tightly packed together and incorporated in the hydraulic lime matrix. The microspheres appeared to be broadly and well dispersed throughout the sample, with no obvious differential settlement of the heavier particles. For the most part, the individual microspheres and sand grains were thoroughly coated and surrounded by the hydraulic lime binder.

It was apparent that formulas #19 and #20, which included the acrylic emulsion additive, had a high percentage of entrained air visible as discrete vacuoles or pores. These small air bubbles dispersed throughout the hardened grout were produced in moderation by foaming of the acrylic during high speed mixing. There are advantages and disadvantages to these air bubbles. The advantages are that small air bubbles make the grout lighter by reducing the unit weight, increasing moisture transmission through the network of open pores, and may improve freeze-thaw capabilities by providing space for water to migrate and for ice crystals to grow without imposing stress. The disadvantage of air bubbles is that the resulting voids reduce the surface area available for bonding, and decrease the density, which can affect tensile and compressive strength.

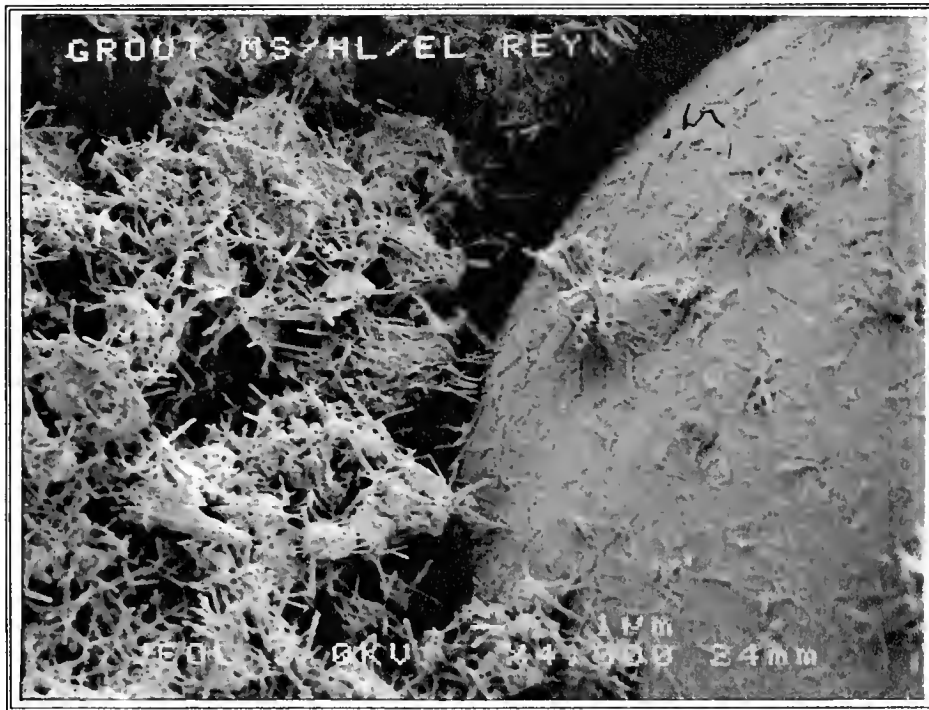
Figure 18. SEM photomicrograph of cured grout formula #20. Notice the acicular needles projecting from the surface of the hydraulic lime particles and the ceramic microsphere on the right. White scale bar measures 1 micron

At 4,000x magnification the hydraulic lime paste can be seen as a film on the microspheres. At this magnification, examination of samples #19 and #20 with the El Rey acrylic emulsion revealed a lattice of acicular needle-like forms extending from the surface of the particles. At first, it was assumed that these formations might be stringers of acrylic emulsion, but after discussion with Getty Conservation Institute scientists Carlos Navarro and Eric Hansen, it was decided that the needles are not amorphous strands of acrylic, but are instead crystalline, possibly formed as a result of the acrylic additive.

Identification of the crystalline material, if it is indeed crystalline, was not conducted, but could be by using X-ray Diffraction. To answer how, and to what extent the addition of the acrylic additive affected crystal growth requires more detailed study. Many variables can alter crystal growth mechanisms in cements (extent of hydration, age, curing conditions, water to binder ratio (Lewin 1982, 121) and impurities in the mix³⁰). It is assumed that the acrylic additive affected the mechanical rather than chemical character of the grout, since the acrylic sets by coalescent film formation, rather than by chemical reaction.

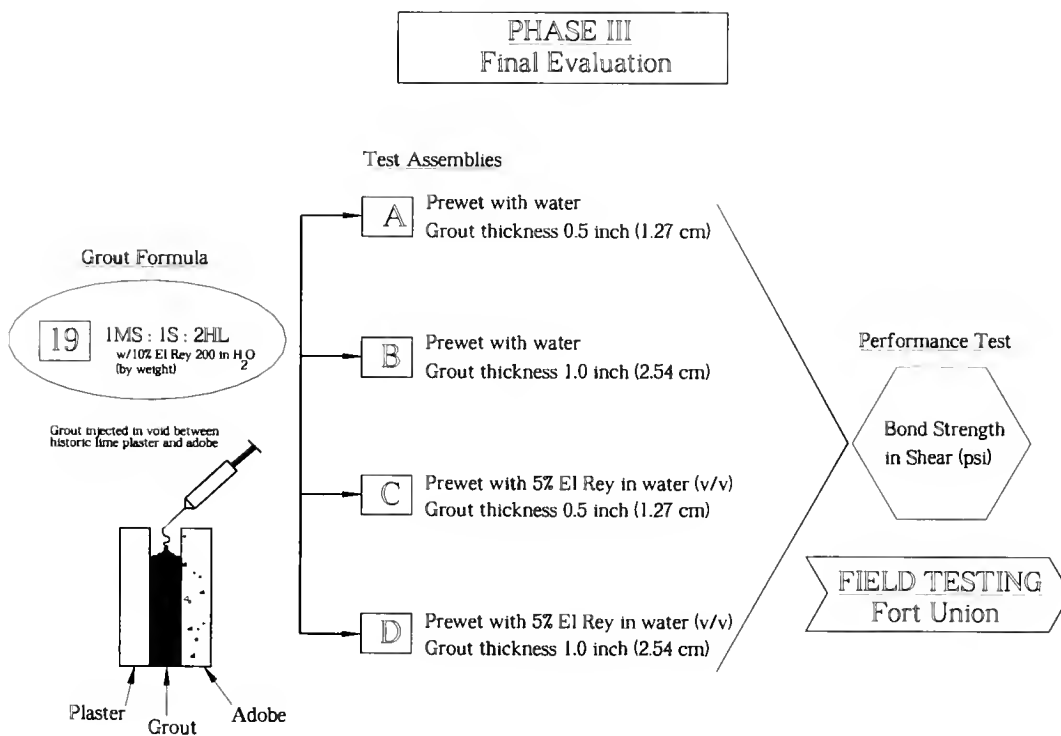
Figure 19. Phase III activity flow chart

The objective of Phase III was to assess the adhesive capability of the selected grout in the laboratory under simulated conditions of use. The grout formula, MS : 1S : 2HL (by weight) with 10% El Rey in H_2O (v/v), was injected between historic Fort Union lime plaster and adobe samples and allowed to cure. Despite problems with the adobe-plaster half of the assemblies, the grout-plaster half was tested for adhesive bond strength in shear by compressive loading.

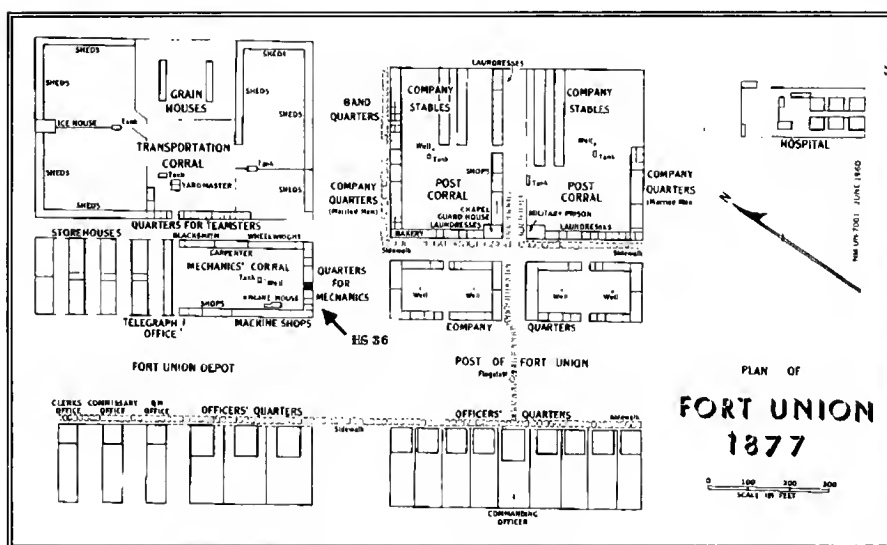
Figure 20. Plan of Fort Union from 1877. The treatment area was in HS 36, known as the Mechanics Corral.

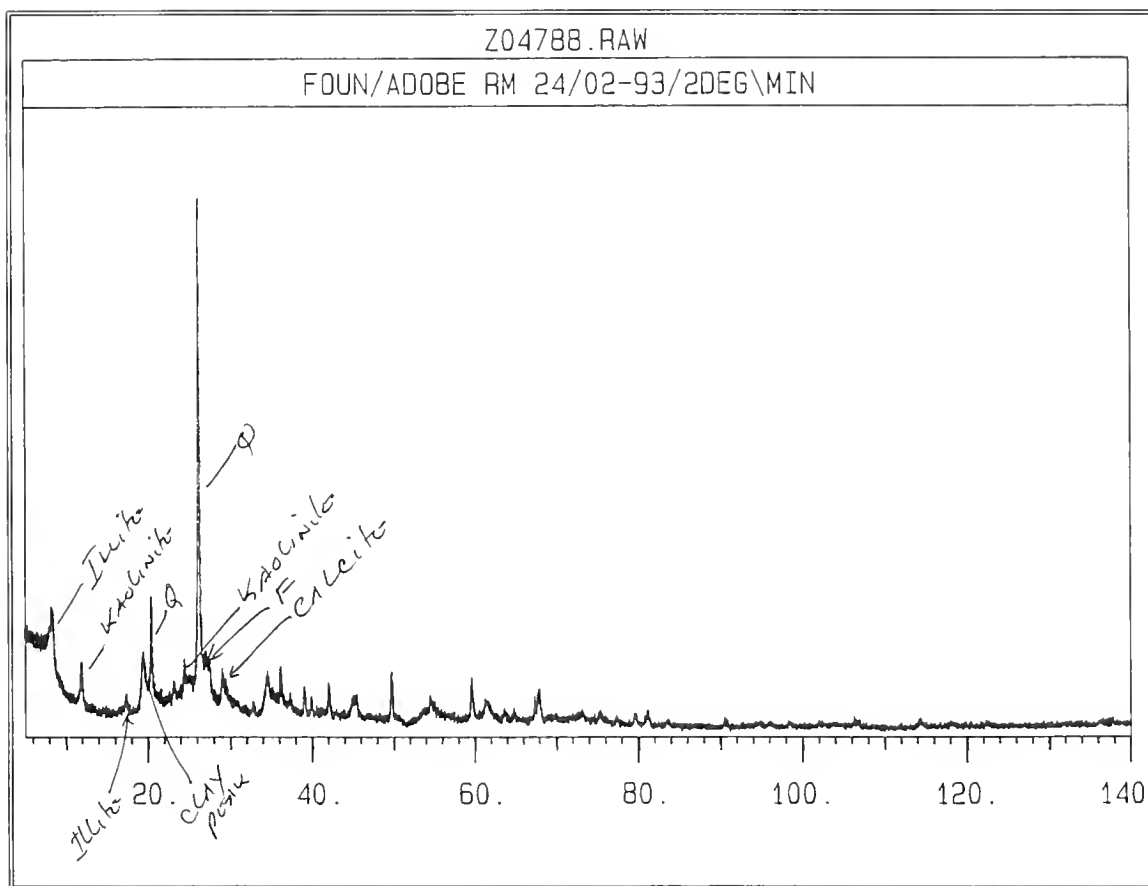
Figure 21. XRD diffractogram of adobe sample HS 36. Annotations by George Austin, New Mexico Bureau of Mines and Mineral Resources

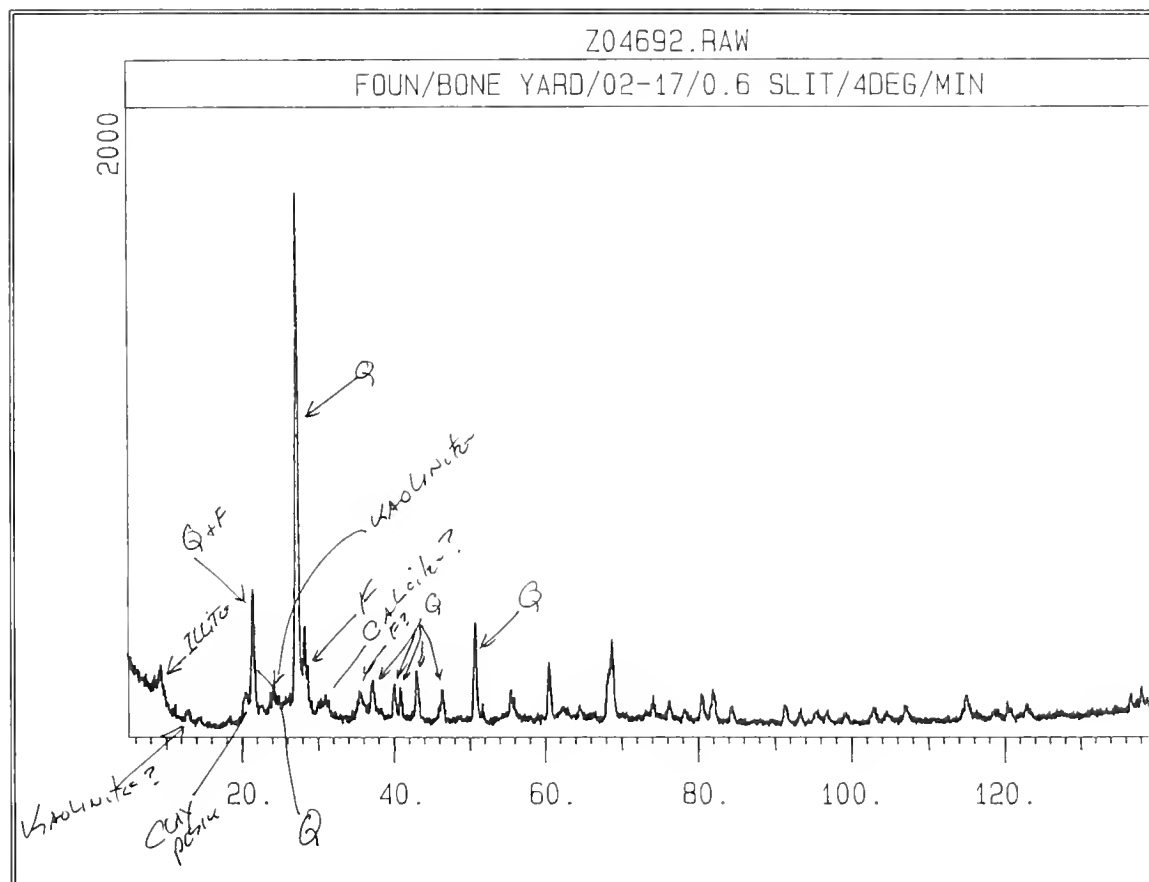
Figure 22. XRD diffractogram of the Boneyard adobe sample. Annotations by George Austin

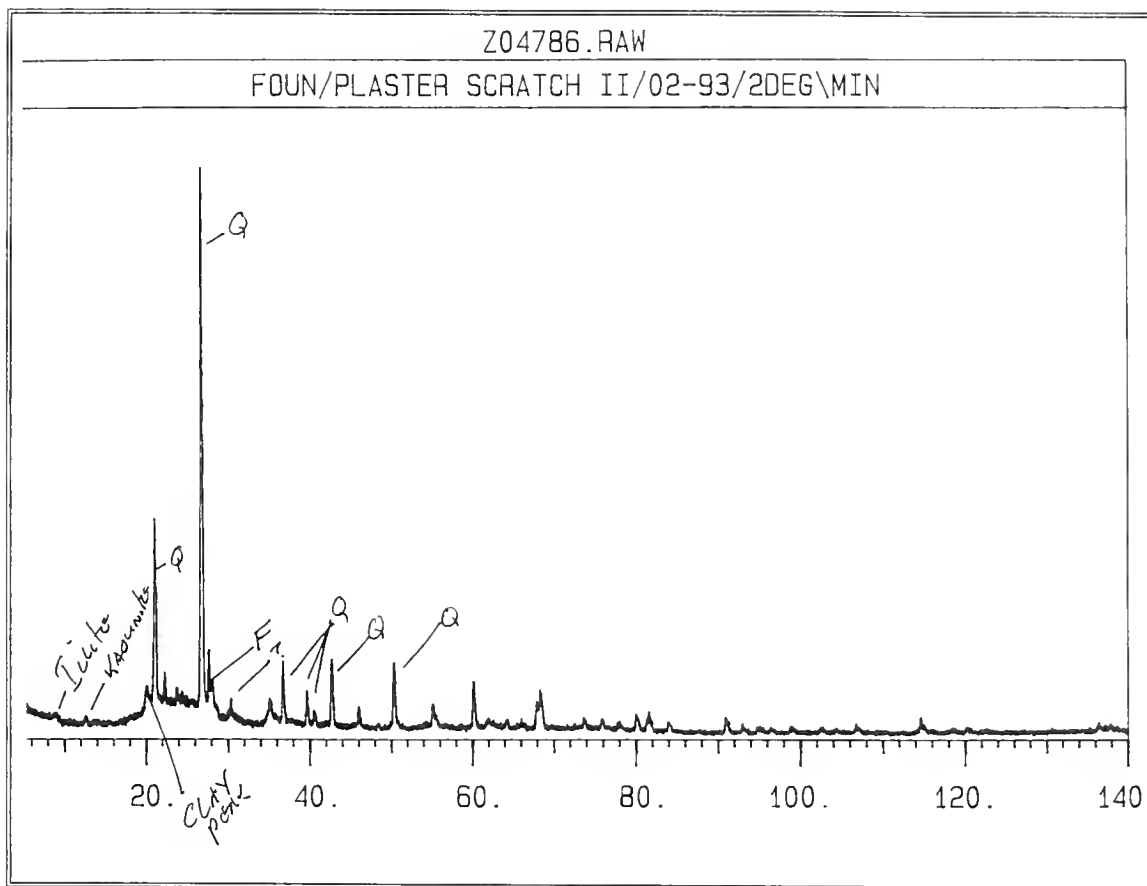
Figure 23. XRD diffractogram of plaster sample(scratch coat). Annotations by George Austin

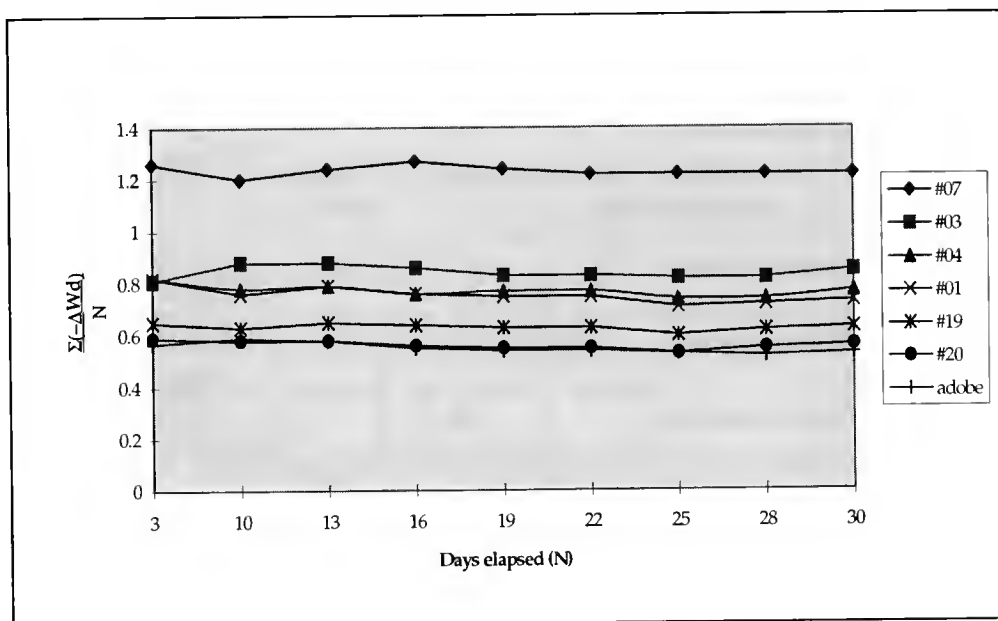
Figure 24. Graph of water vapor transmission data - corrected average weight loss (g/day) over a 30 day period

#01 1MS : 1HL; #03 1MS : 1S : 2HL; #04 1MS : 1S : 4HL; #07 1MS:3.7S:2.5HL w/20% Rhoplex E-330 in H₂O;
 #19 1MS : 1S : 2HL; w/ 10% EL Rey in H₂O; #20 1MS : 1HL w/ 10% EL Rey in H₂O (ratios by weight)

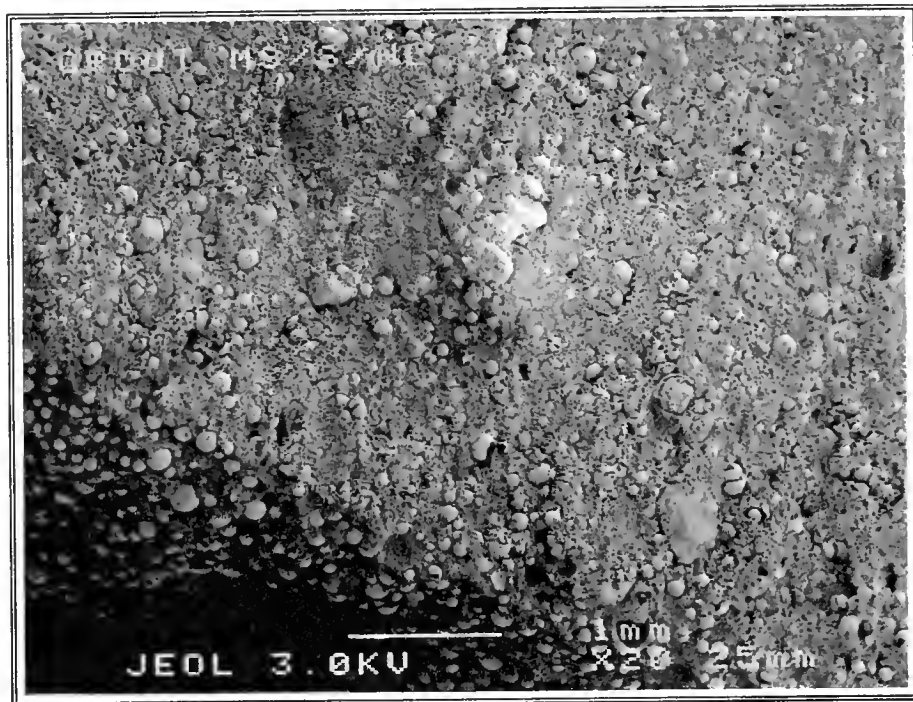
Figure 25. Grout formula #03 composed of 1MS:1S:1HL (w). The large, irregular sized particles interspersed between microspheres and hydraulic lime are sand grains. White scale bar equals 1 mm. (20x)

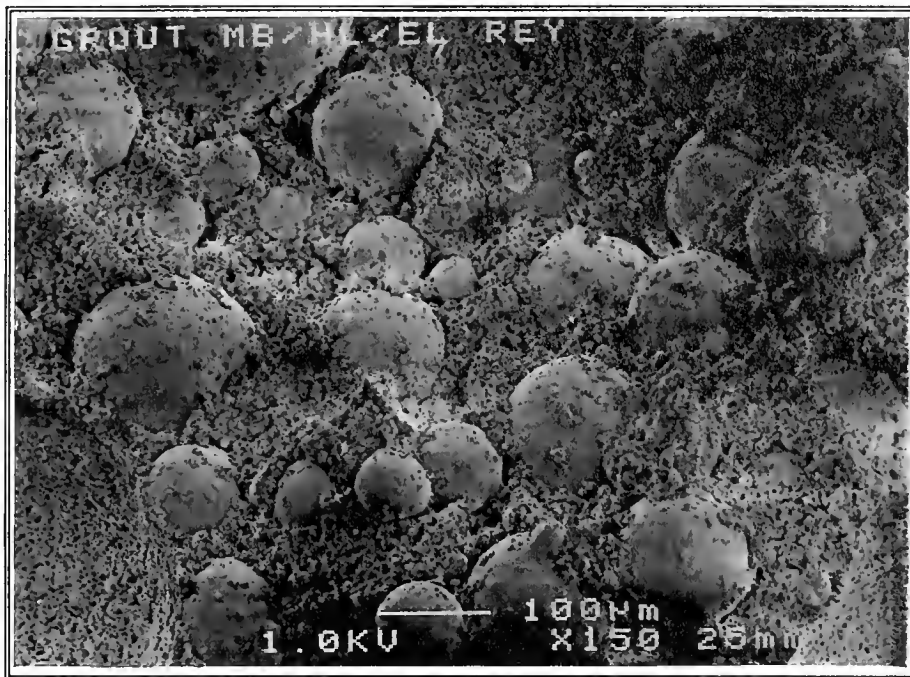
Figure 26. Grout formula # 20 (#01 amended with a 10% acrylic emulsion in H_2O) at 150x. Notice how the well dispersed individual microspheres are thoroughly surrounded by the hydraulic lime matrix.

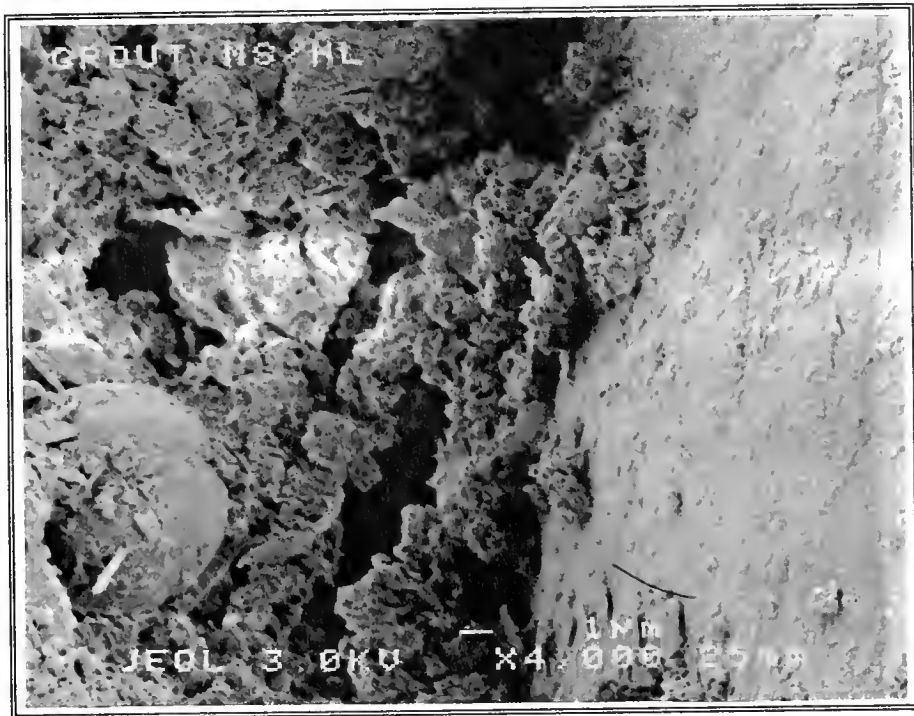
Figure 27. Grout formula #01 composed of 1MS:1HL (w) at 4,000x. A large microsphere is seen on the right, and a smaller sphere on the left. Hydraulic lime fills the space in between. White scale bar measures 1 micron.

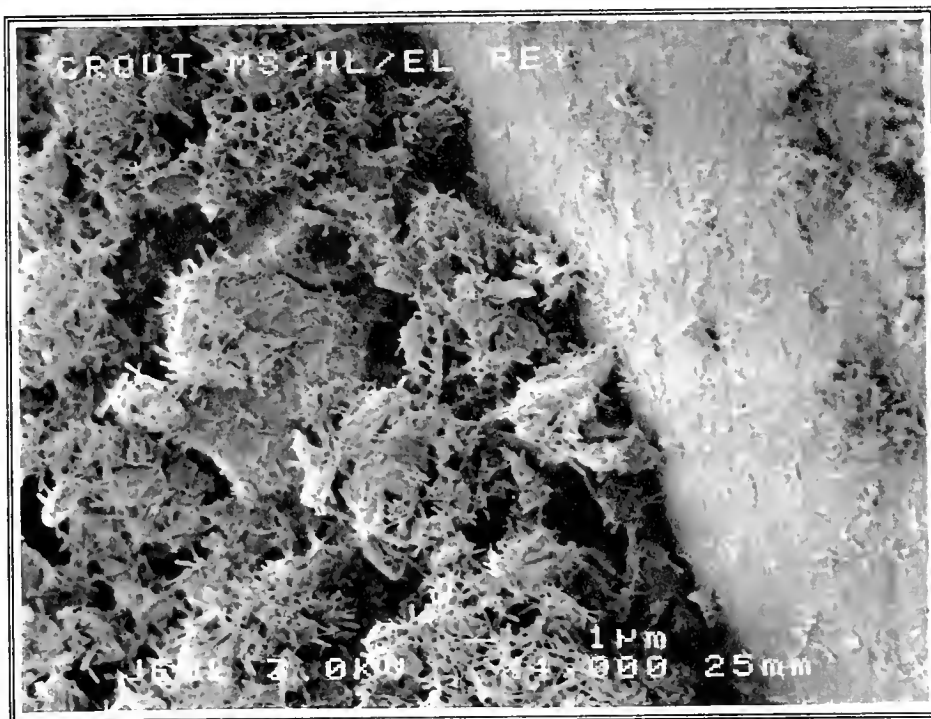
Figure 28. Grout formula # 20 (#01 amended with a 10% acrylic emulsion in H₂O) at 4,000x. The mass on the right is a microsphere; the adjacent platelets are hydraulic lime. Note acicular needle-like formations projecting from the particle surfaces. The needles may be crystalline and may have formed as a result of the acrylic additive.

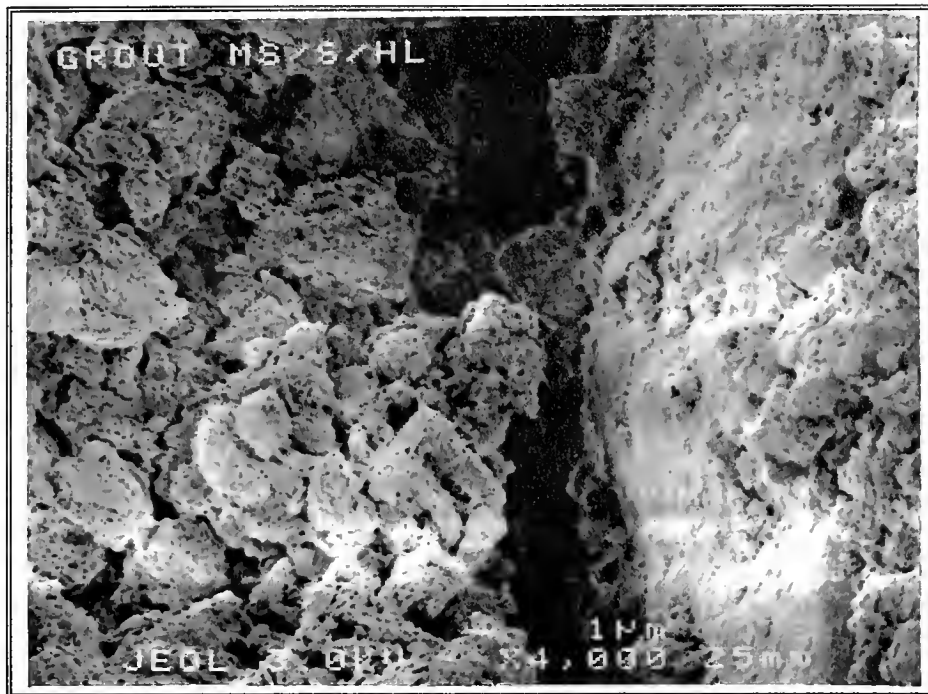
Figure 29. Grout formula #03 composed of 1MS:1S:1HL (w). Hydraulic lime can be seen coating the surface of the microsphere, but in this case, it does not appear to be well bonded to the sphere. White scale bar equals 1 micron. (4,000x)

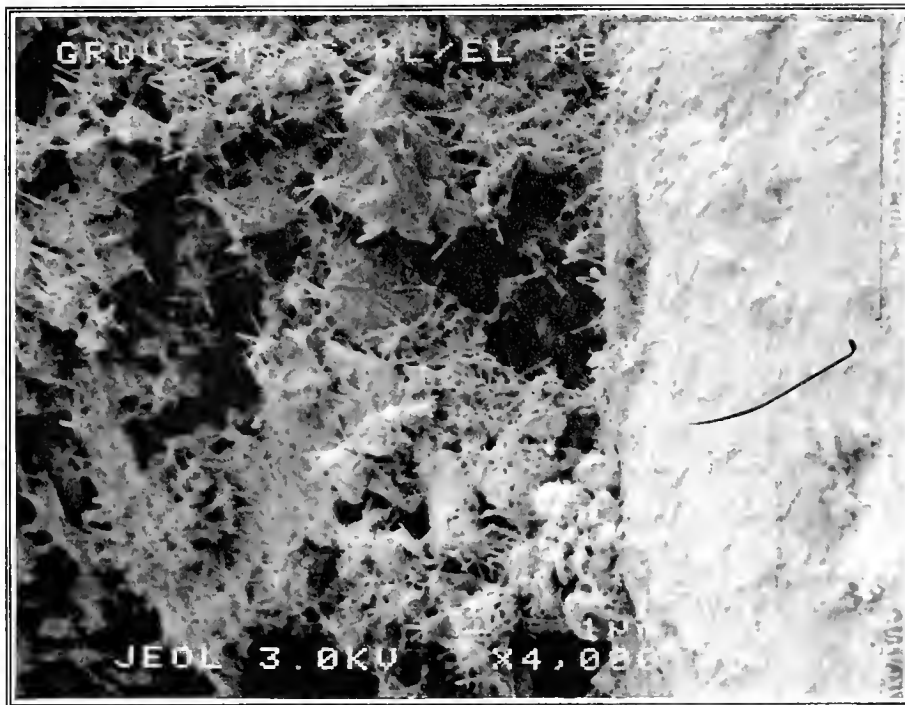
Figure 30. Grout formula #19 composed of 1MS:1S:1HL with a 10% aqueous acrylic emulsion at 4,000x. Again, the needle like projections appear in the acrylic modified grout. The hydraulic lime appears to be well attached to the microsphere or sand grain on the right.
